Two Fatality Board and Care Facility Fire Salvation Army Rehabilitation Center

Miami, Florida

This is Report 090 of the Major Fires Investigation Project conducted by Varley-Campbell & Associates, Inc. under contract EMW-94-C-4423 to the United States Fire Administration, Federal Emergency Management Agency.

November 11, 1995

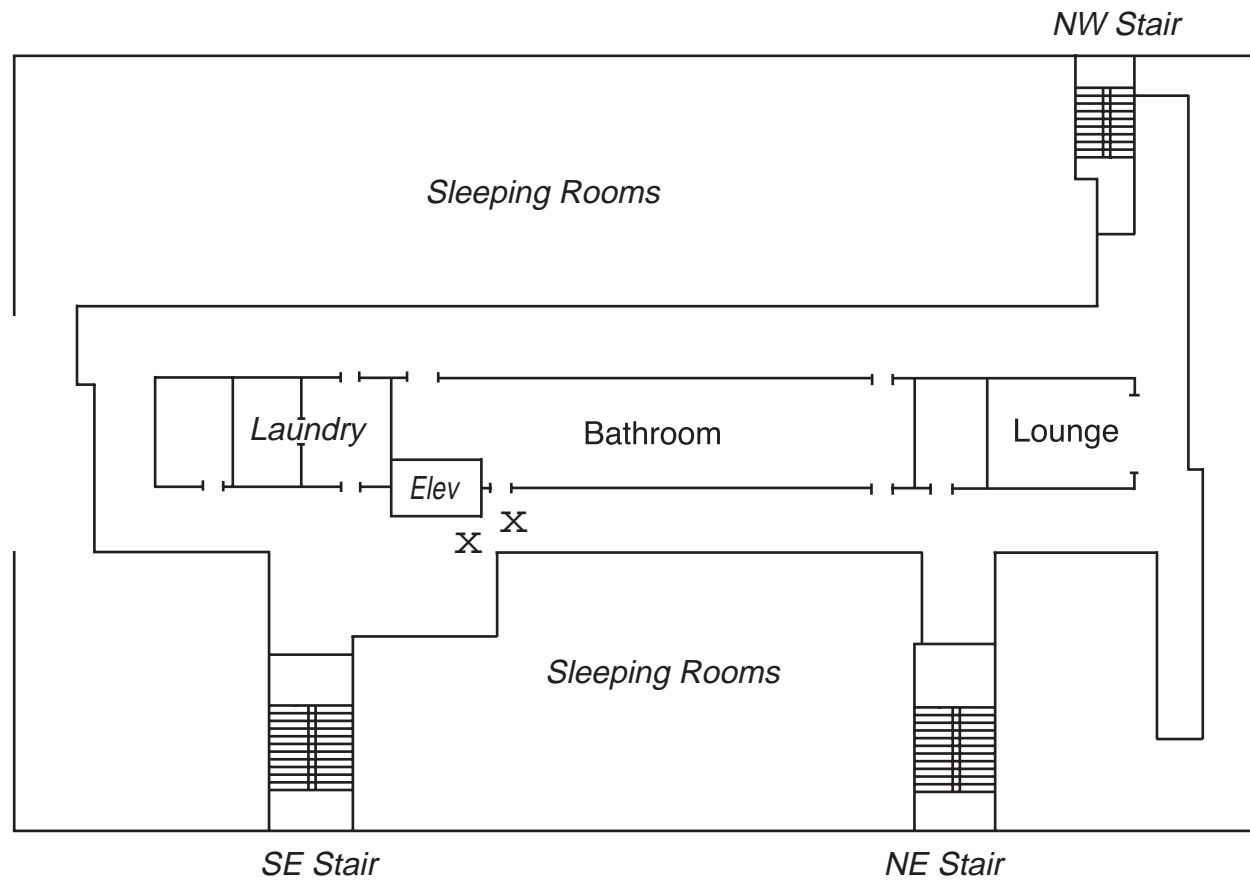
Figure 3

Search and rescue efforts on the second and third floors continued. The crew of Engine 12 crew located two unconscious victims in the hallway outside the bathroom on the third floor. They were removed and transported to a local hospital, where they were pronounced dead.

Third Floor
Indicates location of fatalities X

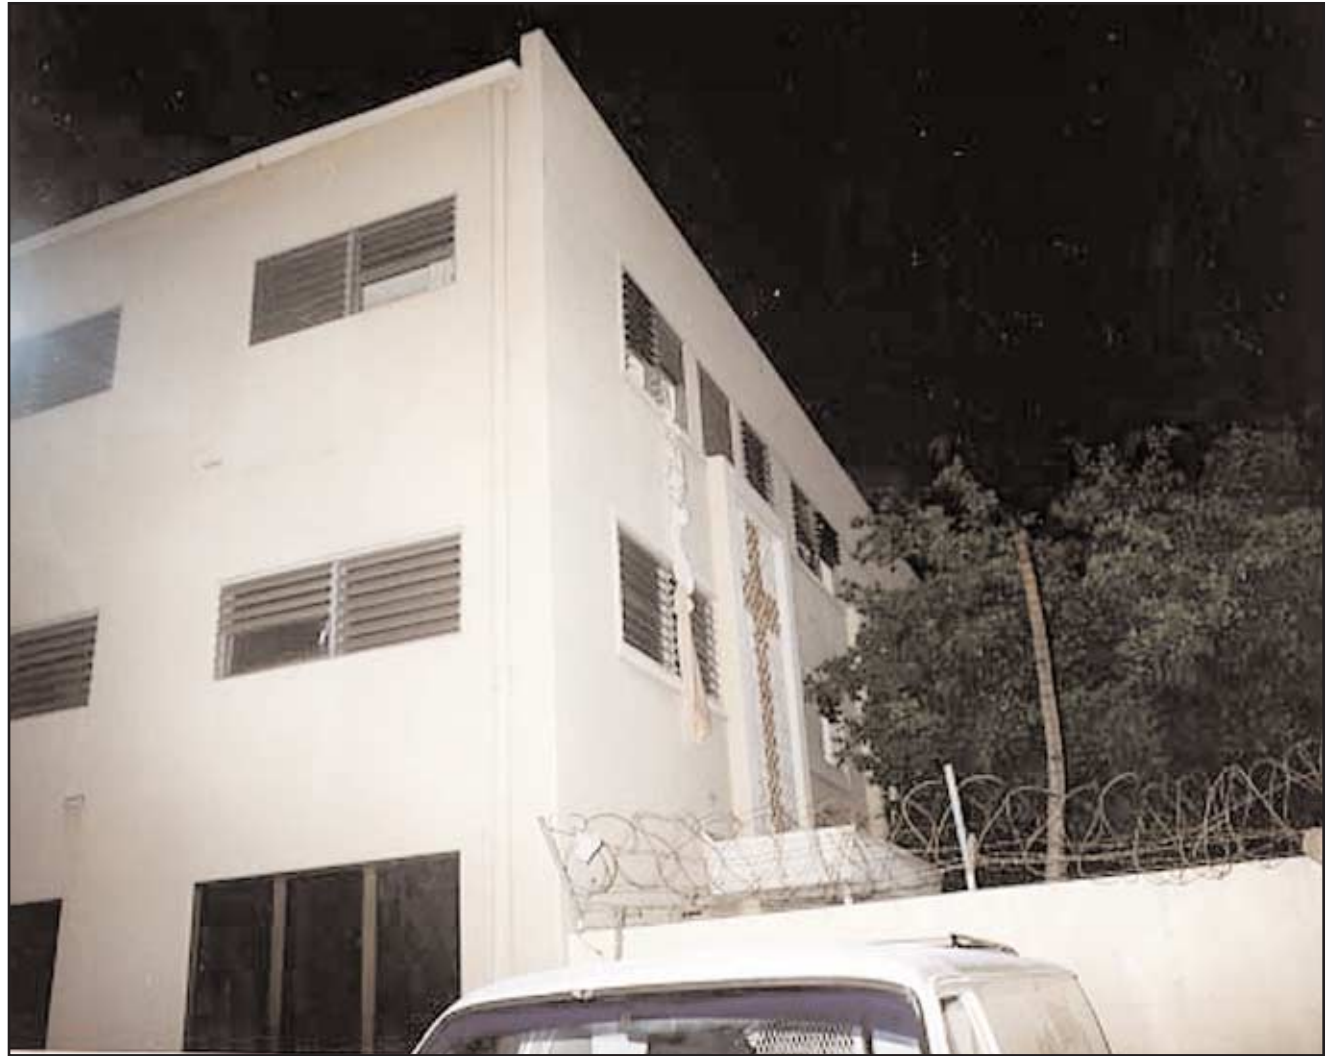
The building was equipped with hurricane shutters which were installed on the outside of the building over the glass windows. The shutters hampered the residents attempting to exit through the windows, when the corridors became impassable because of heavy smoke conditions. Some residents used furniture to break out the shutters. There were instances of persons becoming stuck in windows from which the shutters had only been partially removed.

Each of the windows in the building was equipped with a permanent hurricane shutter. Installed on the outside of the operable glass windows, the shutters consisted of several interlocking metal louvers mounted on two vertical tracks. They could be opened and closed from the inside with a crank and lever mechanism, similar to awning windows. The shutters effectively precluded egress from the windows without their forcible removal. (See Appendix B, photograph 1.)

1. Southeast corner of the Rehabilitation Center. Front entrance is just north of the razor wire topped wall. Note permanent hurricane shutters installed on the outside of the windows. Some residents tied sheets together and climbed from the windows after breaking out the shutters.

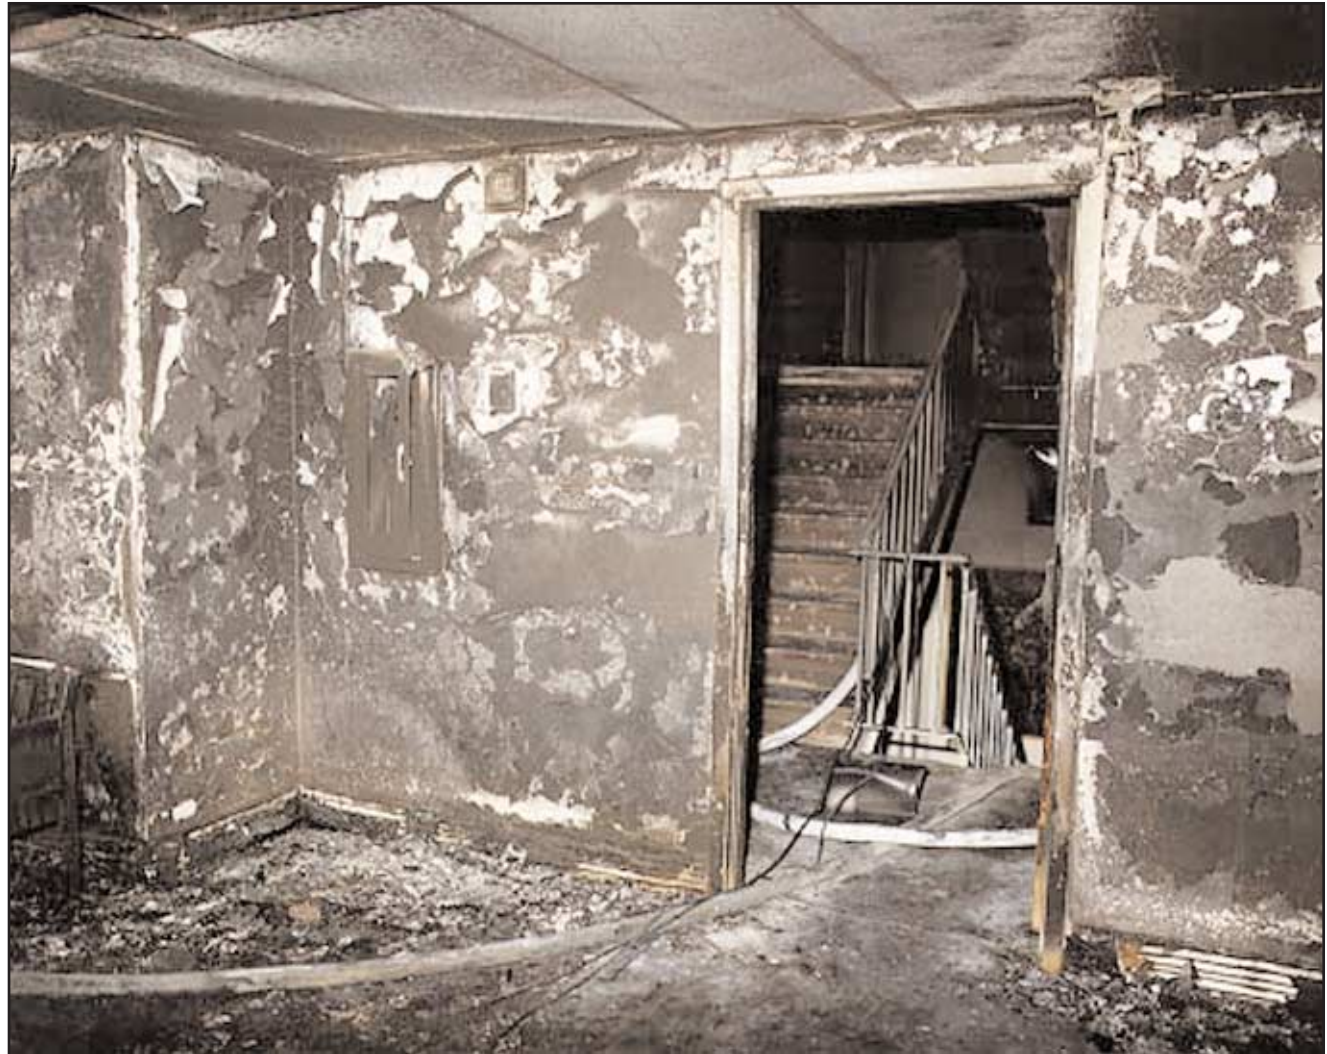
2. Doorway opening from SE stairway into office waiting area on second floor, adjacent to where investigators determined the fire originated.

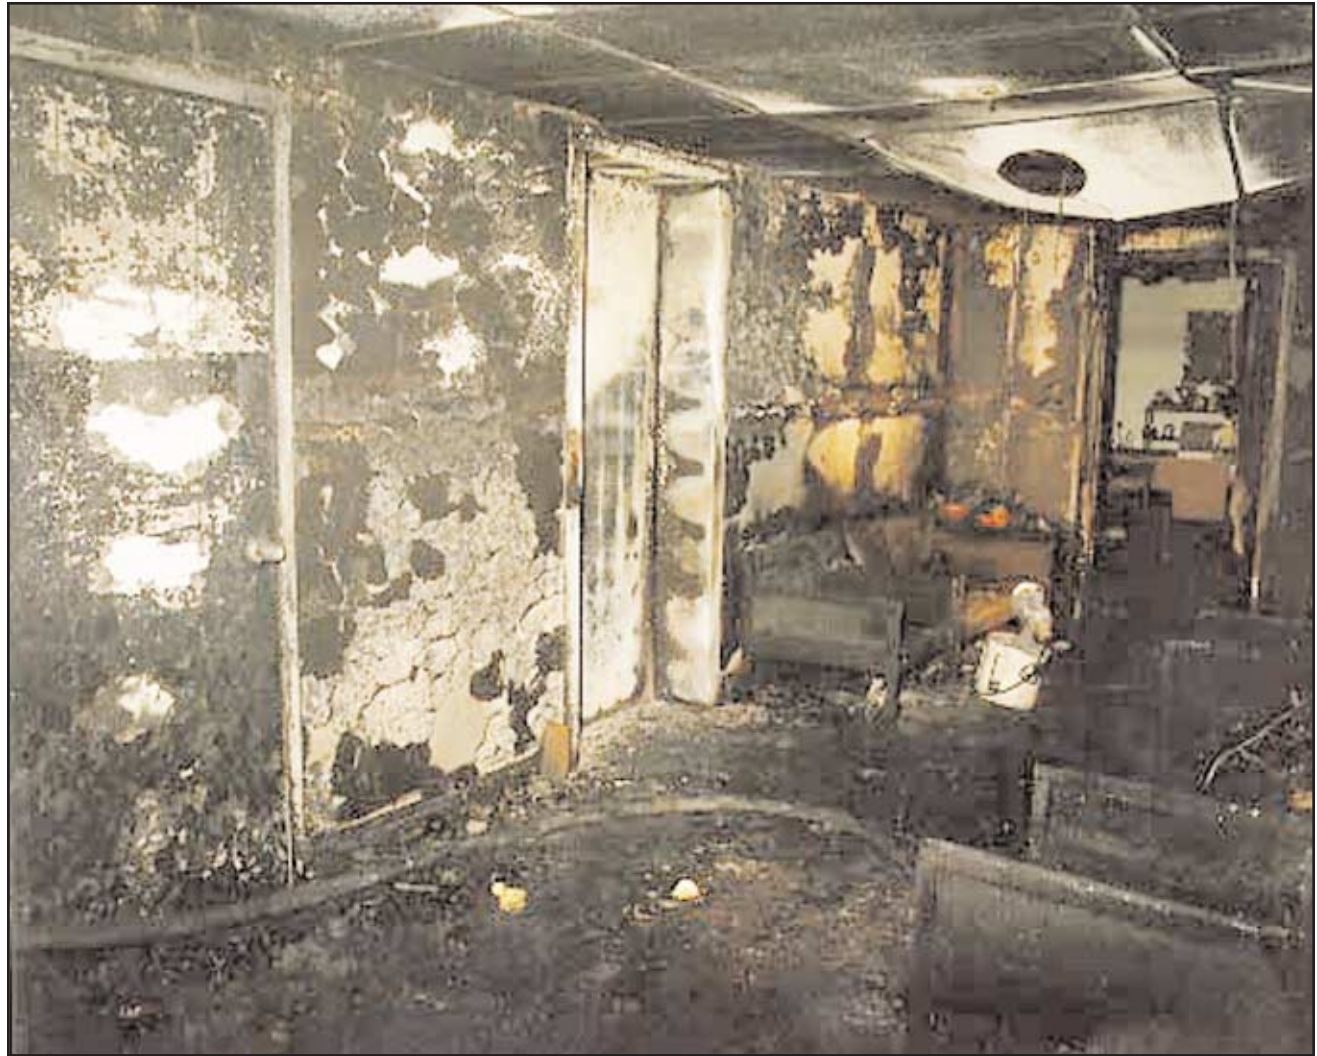
The office waiting area on the second floor where the fire originated was furnished with upholstered chairs, end tables and racks of magazines and promotional literature. Chair cushions were shown to be highly flammable in tests conducted by the fire department after the fire and shown to produce large quantities of thick black smoke.

3. View of office waiting area on second floor from the SE stairway door.

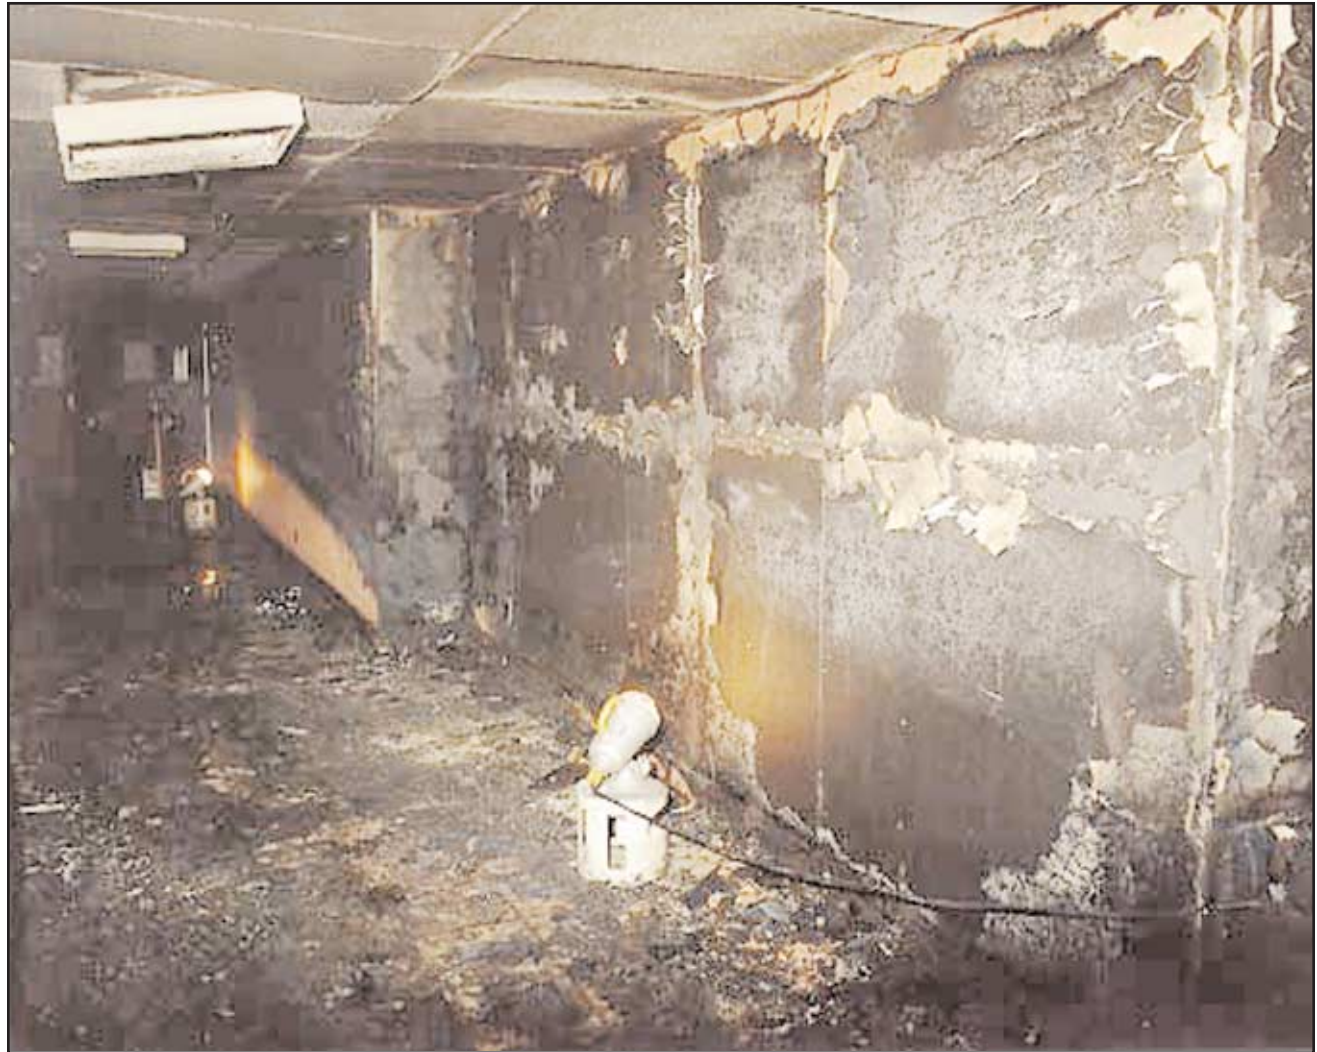
Wallcoverings in the Center varied from plywood paneling and painted gypsum wallboard to vinyl wallcoverings. Investigators observed that the vinyl wallcovering in the area of origin, and leading down the second floor hallway from the area of origin, was completely burned away.

4. First view of hallway leading from office waiting area to residential areas of the second floor.

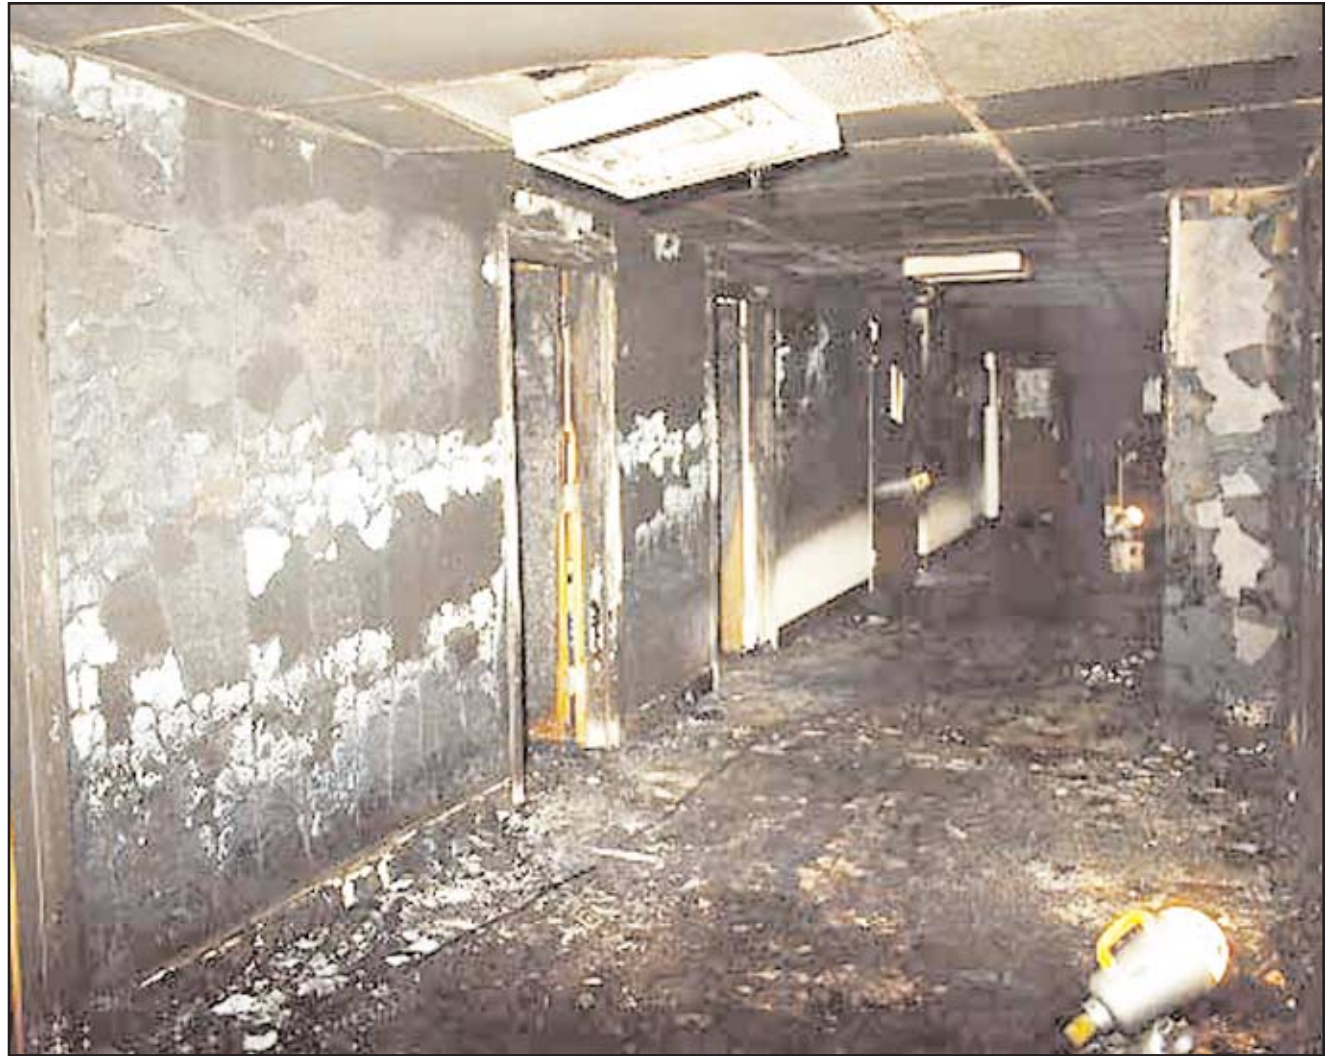
5. Second view of hallway leading from office waiting area to residential areas of the second floor.

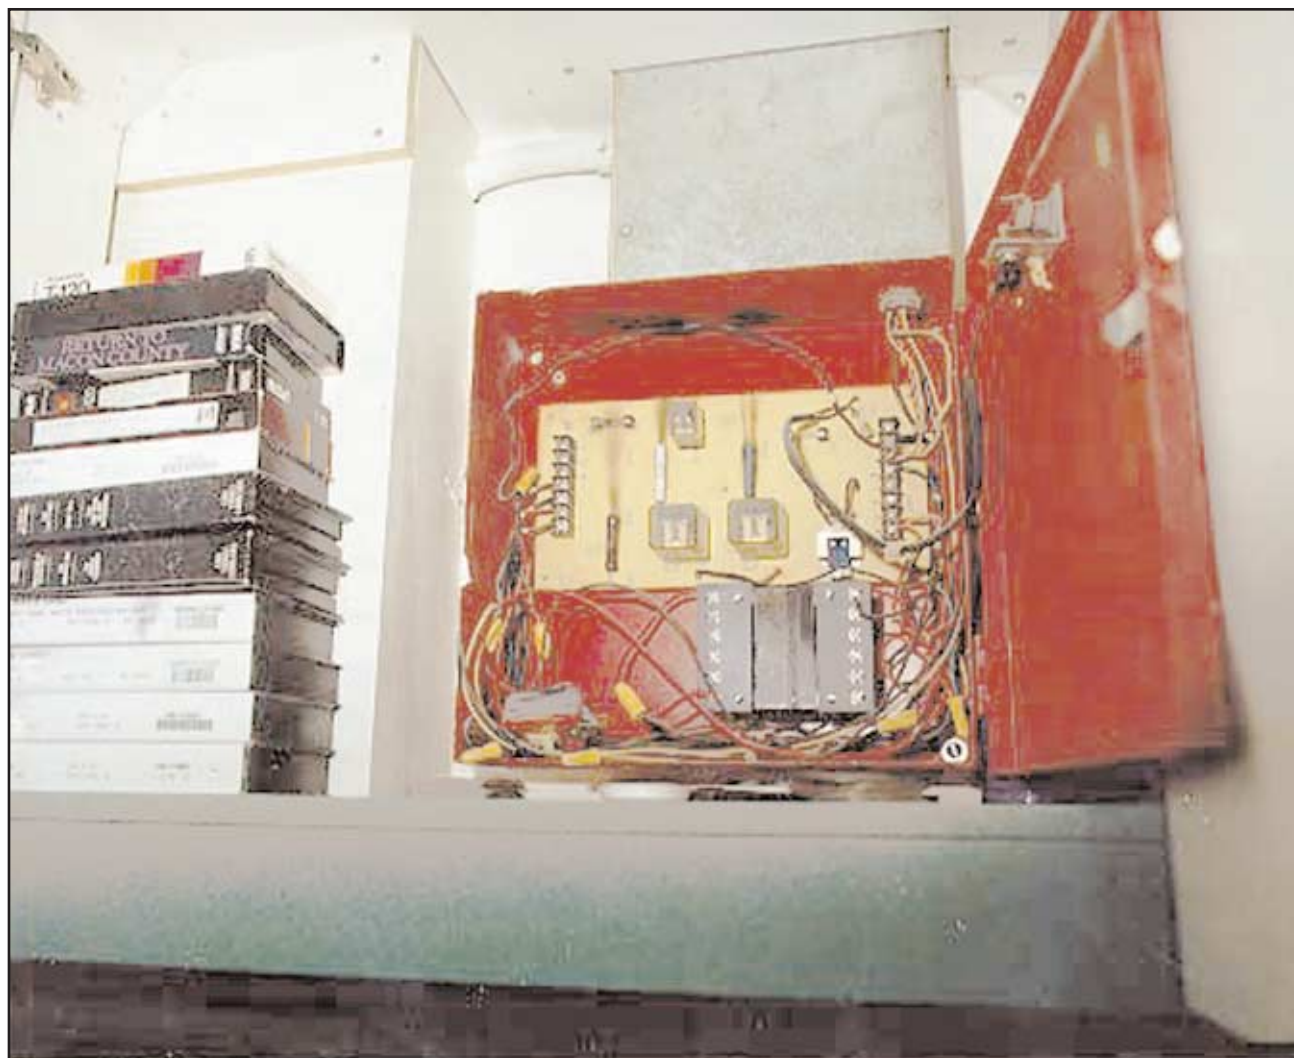
The fire alarm system control panel was mounted on a wall in a storage cabinet in the first floor watch room. The control panel was completely out of sight, hidden behind closed cabinet doors with cleaning supplies stacked in front of it. The Center staff, when questioned, was unaware of its existence. A switch of the type normally used as a wall switch had been installed in the control panel, providing an on/off switch for the system. When located after the fire, the switch was found in the “off” position.

There were no records or staff recollection to indicate when the fire alarm system had last been tested or inspected. The system was not connected to a central station or alarm monitoring service. There was no public announcement system in the building.

6. Fire alarm control panel. The panel was located inside a cabinet in the first floor front office. Note the on/off switch in the bottom left hand corner of the box.
